An Engineering Geological Investigation Into Pit Slope Stability At Macraes Gold Mine, Macraes Flat, Otago, New Zealand.

A thesis submitted in partial fulfilment
of the requirements for the degree of
Master of Science in Engineering Geology
at the University of Canterbury
by **Aaron P. Chapple**

**University of Canterbury,
Christchurch,
New Zealand,
1998.**

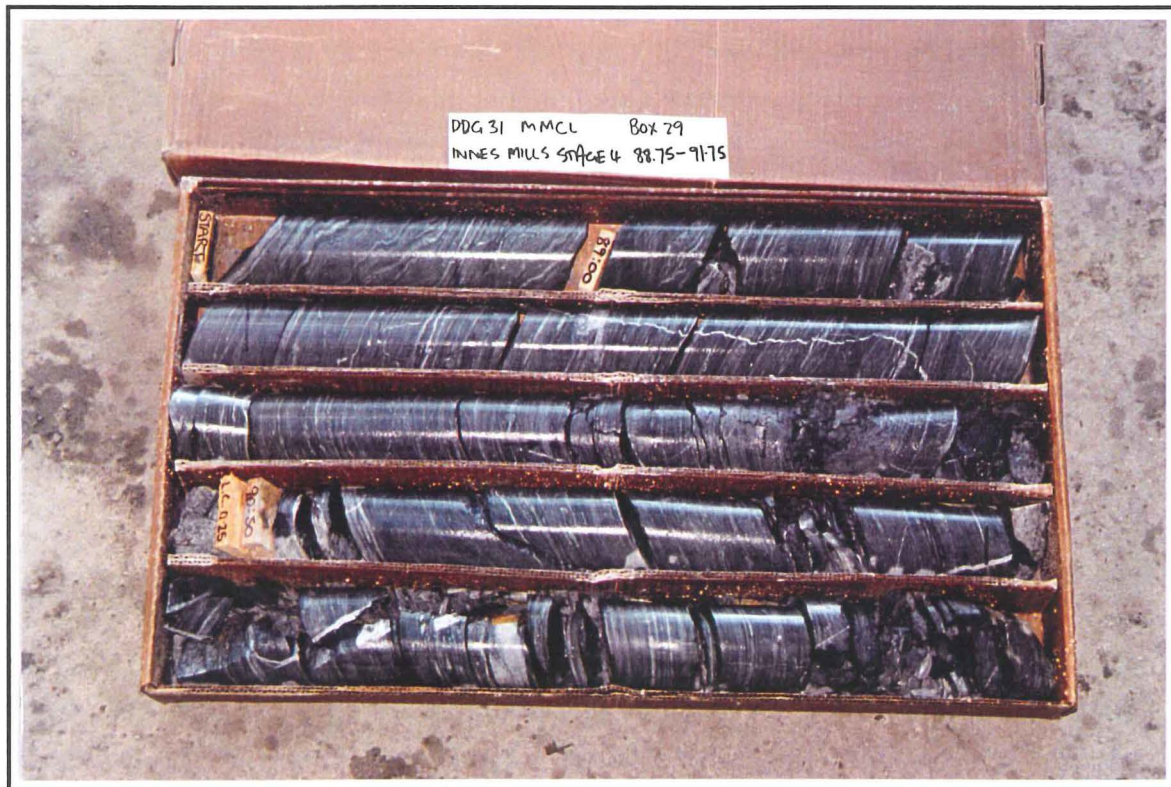
Figure 2-4: Core box at Macraes showing cause of sampling bias in core selection for UCS testing. The schist in the bottom two rows of the core box is more heavily broken into shorter lengths along schistosity than the schist in the top two rows of the core box, making it unsuitable for testing according to the ISRM guidelines. Core size is HQ = 61mm diameter (Hole No. DDG31 - Box 29, 88.75m -91.75m).

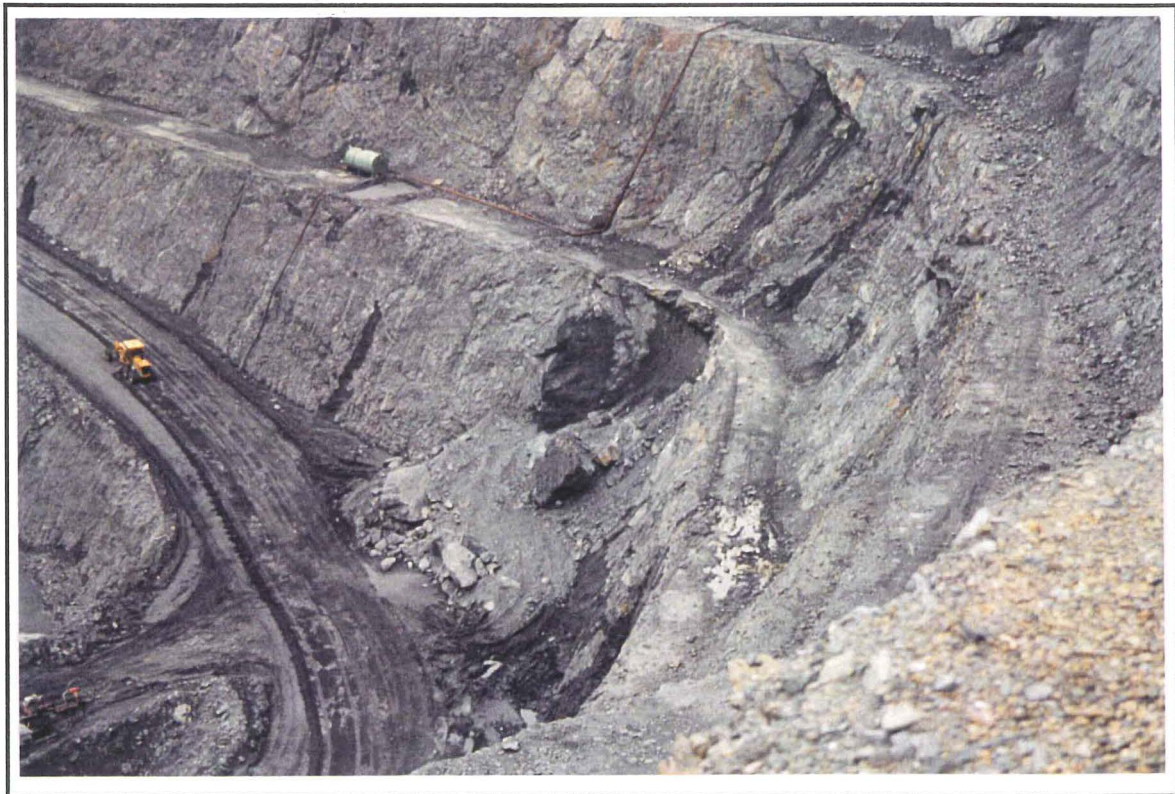
While high angle planar failures generally have small volumes (50-100m³) for pit slope failures at the mine, these failures are still of importance. High angle planar failures are most likely to occur soon after the excavation of a bench and removal of toe support, and as such are a significant hazard to mine personnel and equipment in the area at the time of failure. In addition, even where failure is not immediate after excavation of a bench (e.g. RH34 & RH35), later failure following precipitation, blasting etc., adjacent to a haul road may represent a significant hazard to equipment and personnel in the vicinity at the time of failure (Figure 4-2).

Figure 4-2: Failure RH30 adjacent to main haul road. Failures such as this represent a significant hazard to equipment in the area at the time of failure. Grid reference: 69785mE, 15145mN.

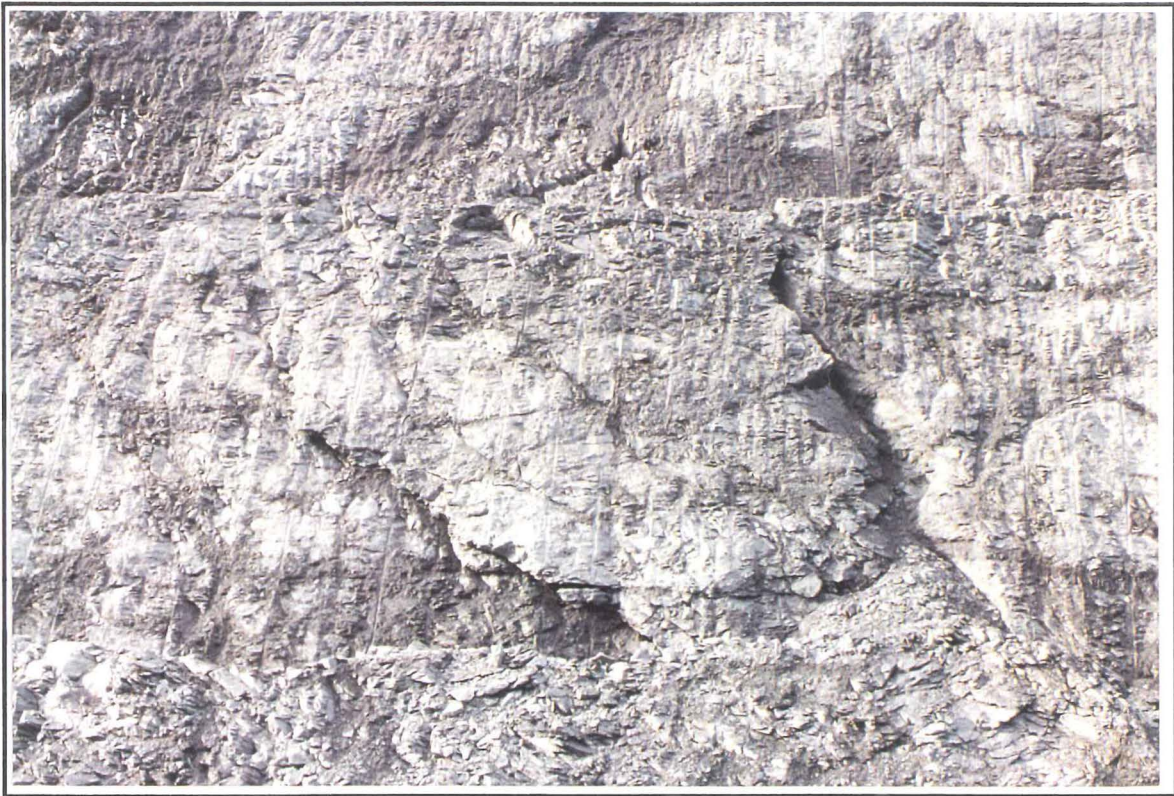
Figure 4-5: Failure RH33. Grid reference: 70070mE, 15070mN

Back analyses of failures IM3 and RH33 were performed and are presented in Appendix F6. Resulting back analysis curves showed that, assuming there was no cohesion acting along the failure surface, the effective ϕ angles are $\text{IM3} = 14^\circ$ and $\text{RH33} = 9^\circ$. For both analyses an increase in cohesion to 1kPa shows a rapid drop in ϕ to 10° (IM3) and 6° (RH33). The low calculated shear strength for RH33 compares favourably with that measured through ring shear testing (6.1°). As noted in Chapter 2, because faults at Macraes are structures which have been subjected to large strains in the past, cohesion would be expected to lie close to zero.

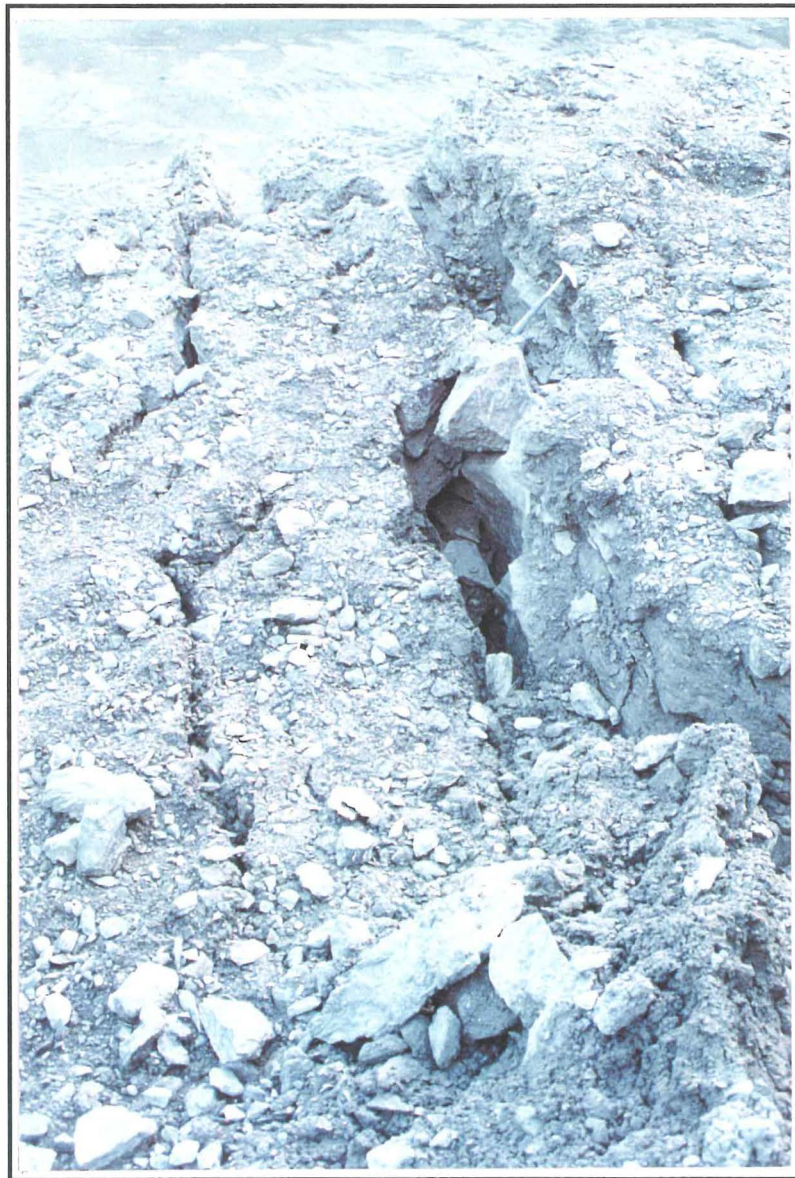
Field observations and factor of safety analyses for both RH33 and IM3 support the hypothesis that groundwater pressures formed along the bounding surfaces to the failure block are an important geotechnical factor in driving failure. Groundwater pressures along these releasing defects that bound the failure will create a hydrostatic force that effectively pushes the block from behind. The slow movement of these failures and consequent dilation of the failure block may be enough to stop its movement, as groundwater pressures are alleviated through the creation of new secondary permeability by the opening up of the failure block along discontinuities (Figure 4-7).

Figure 4-7: Cracking along jointing trending to 017° in 360mRL bench of failure RH33. Dilation of rock mass along joints such as these may be enough to provide natural drainage paths to relieve groundwater pressures driving failure and thus stop further failure movement. Note hammer for scale. Grid reference: 70080mE, 15065mN, 360mRL.

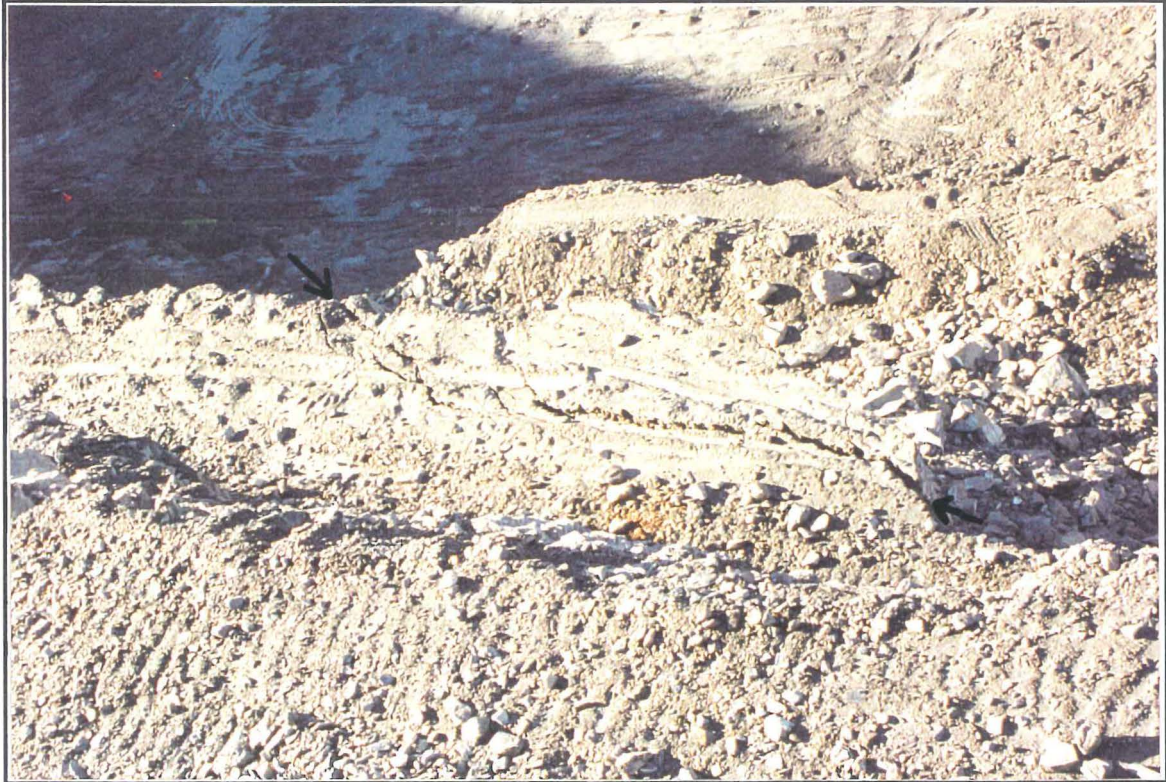
Figure 4-9: Cracking along 460mRL bench illustrating continued development of RH31 can be expected. Grid reference: 70050mE, 15325mN

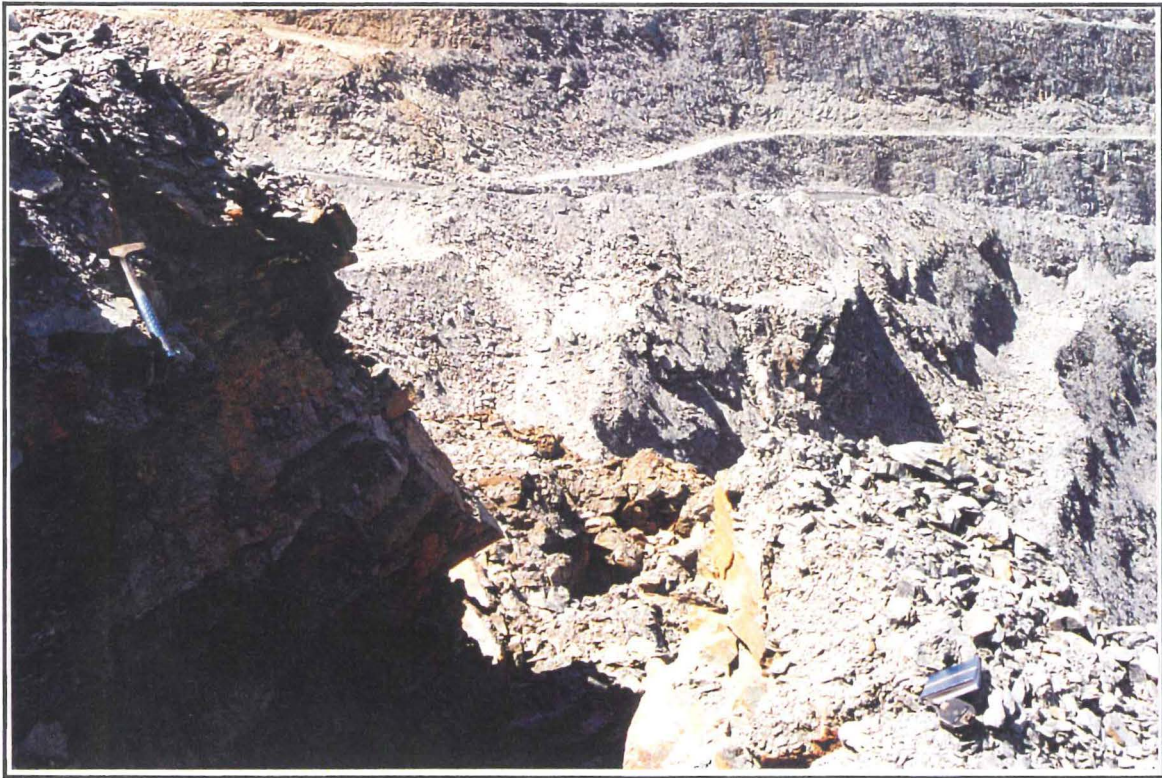
Figure 4-14: Cavernous opening along north-south striking joints formed as weathered schist material slowly dilates and topples into void formed by failure of wedge. View is to the south and note hammer for scale on eastern margin of opening. Grid reference: 70275E, 15275N.

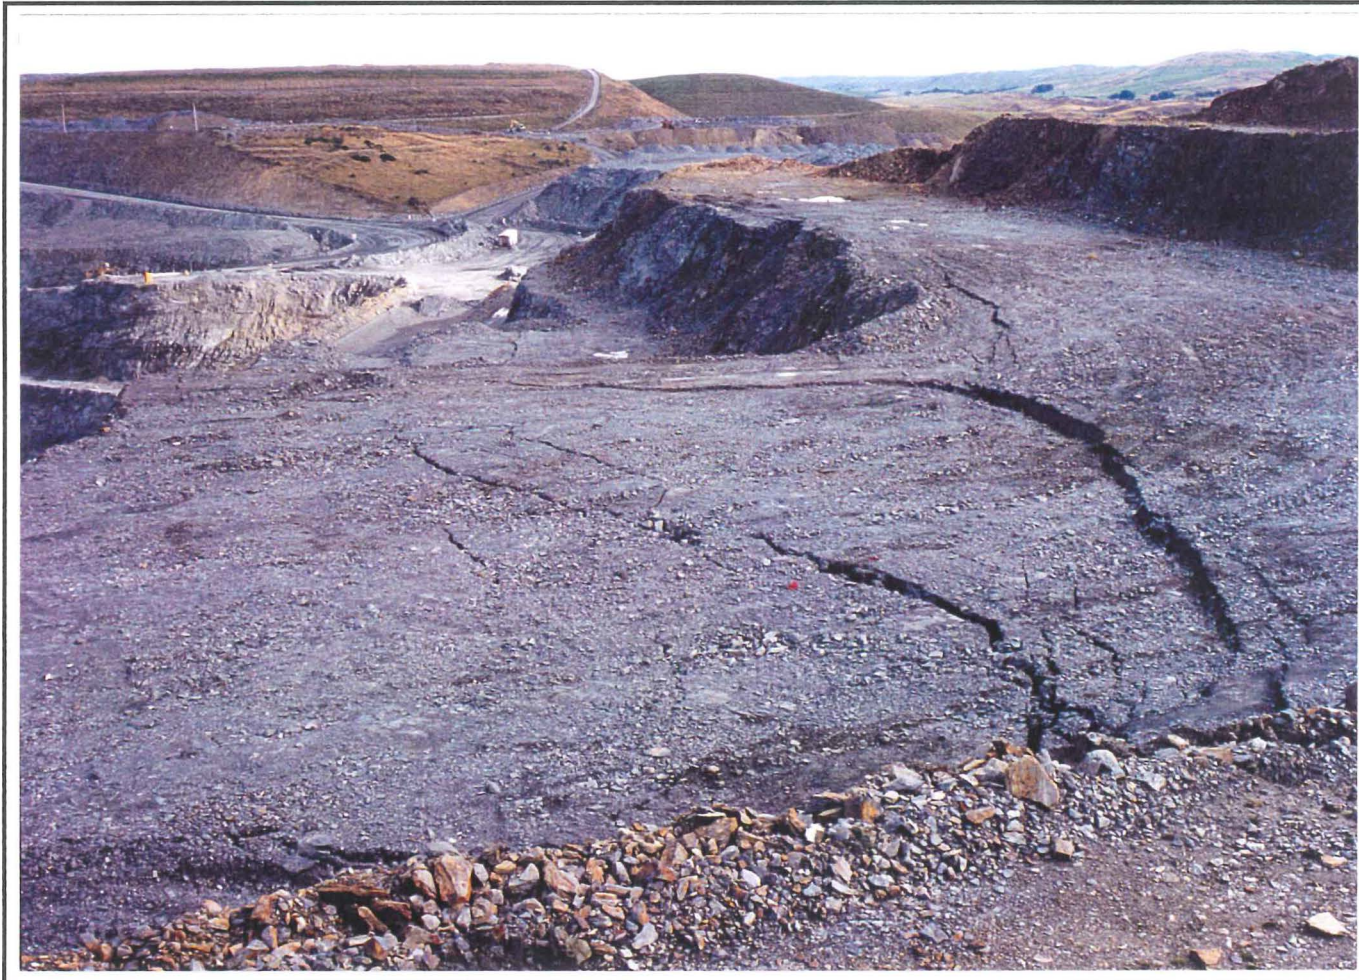
Figure 4-26: Scarp formed along back fault in 460mRL bench. Note tension cracks along joints in front of scarp formed from dilation of the rock mass. Grid reference: 70075mE, 15425mN.

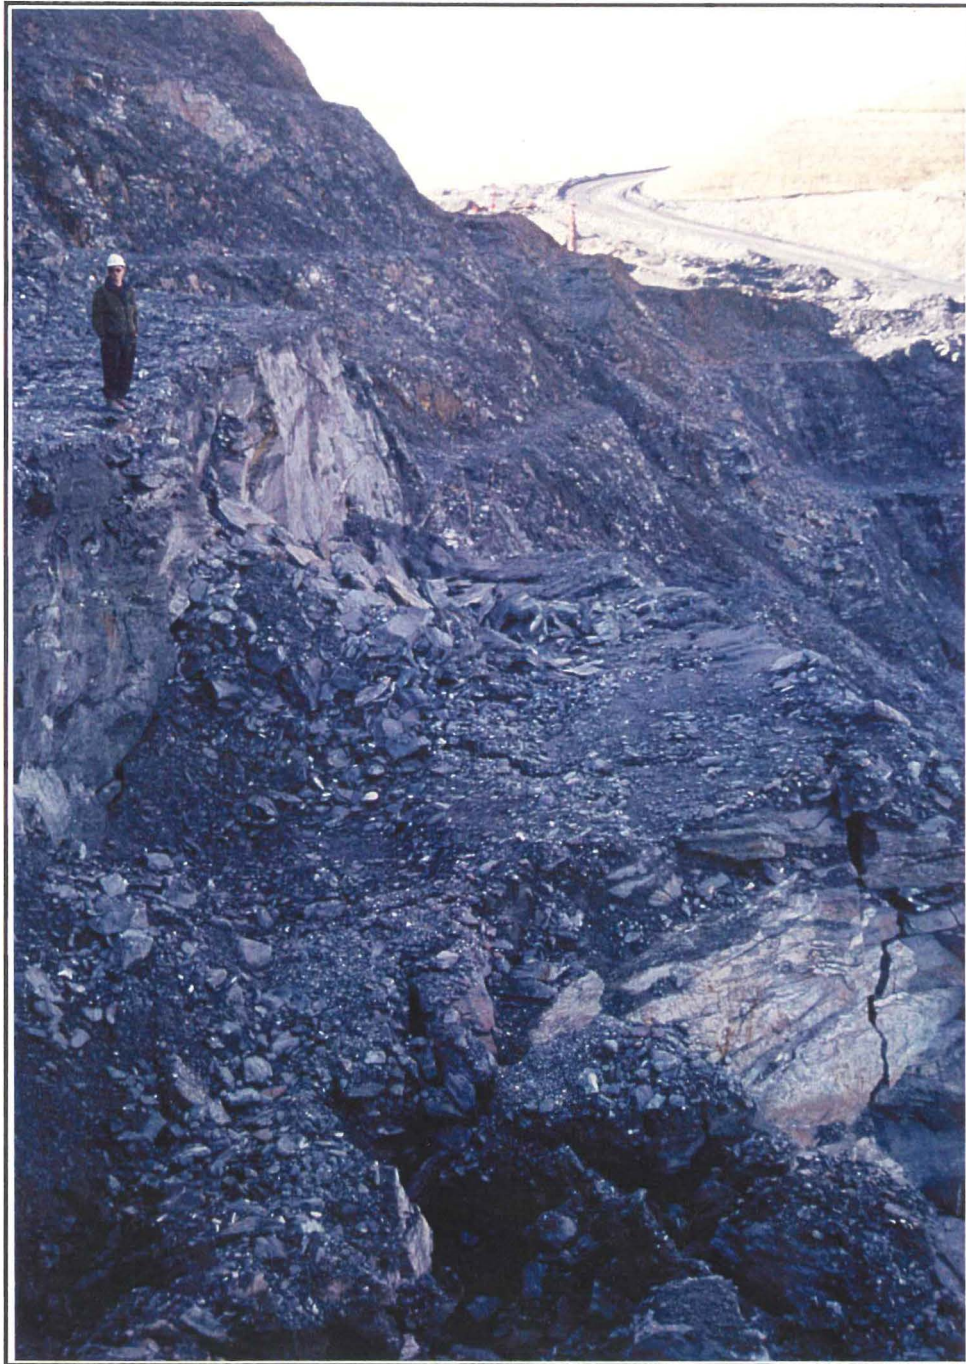
Figure 4-28: Collapse of 430mRL bench in central area of RH28. Bench is released by vertical joint trending sub-parallel to pit slope. Grid reference: 70080mE, 15360mN.

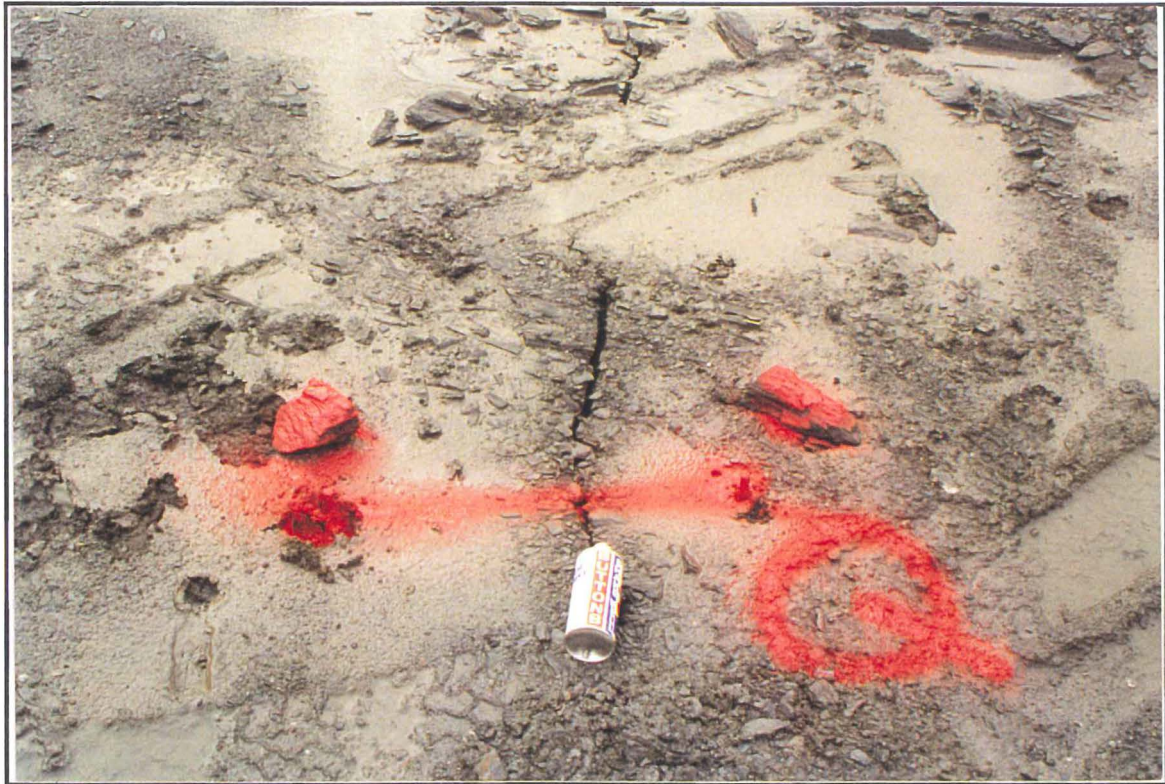
Figure 4-29: Typical set up of steel crack pins across a crack on failure RH28. Crack pin Q, grid reference: 70200mE, 15430mN

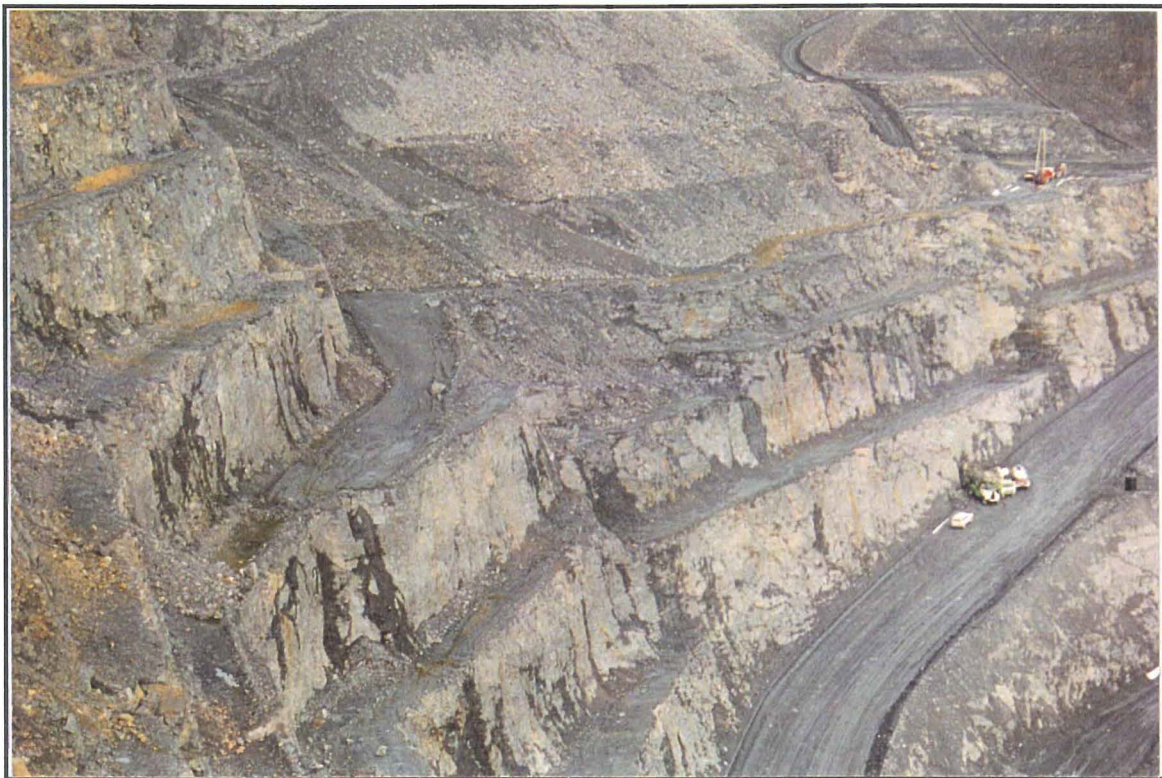
Figure 5-2: Photo of the eastern wall of Round Hill pit following a day of rainfall. Wet patches indicate groundwater seepage from a number of faults present in the pit slope.

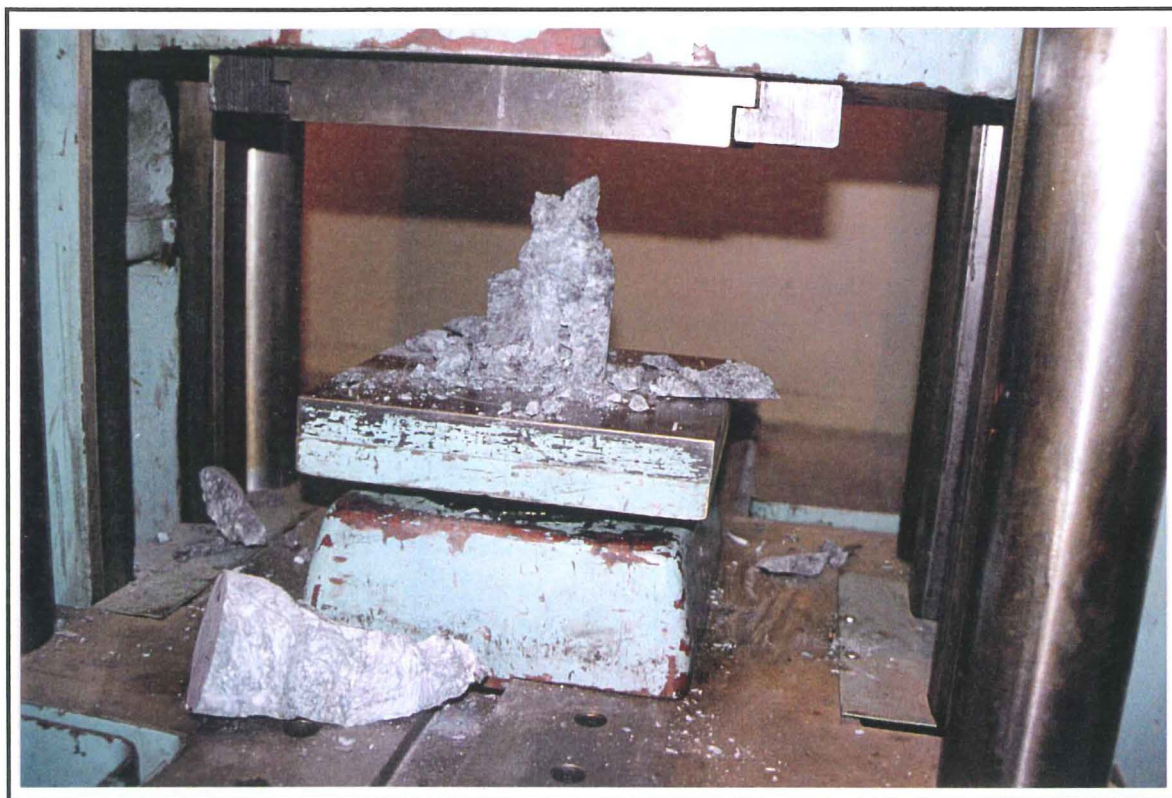
Figure C2-1: The Department of Civil Engineering's, concrete testing machine used for uniaxial compressive strength testing in this study.

Testing was undertaken in the University of Canterbury Civil Engineering department using concrete testing equipment (Figure C2-1). PQ core (83mm diameter) and HQ core (61mm diameter) were both tested at a stress rate of approximately 0.1 MPa.

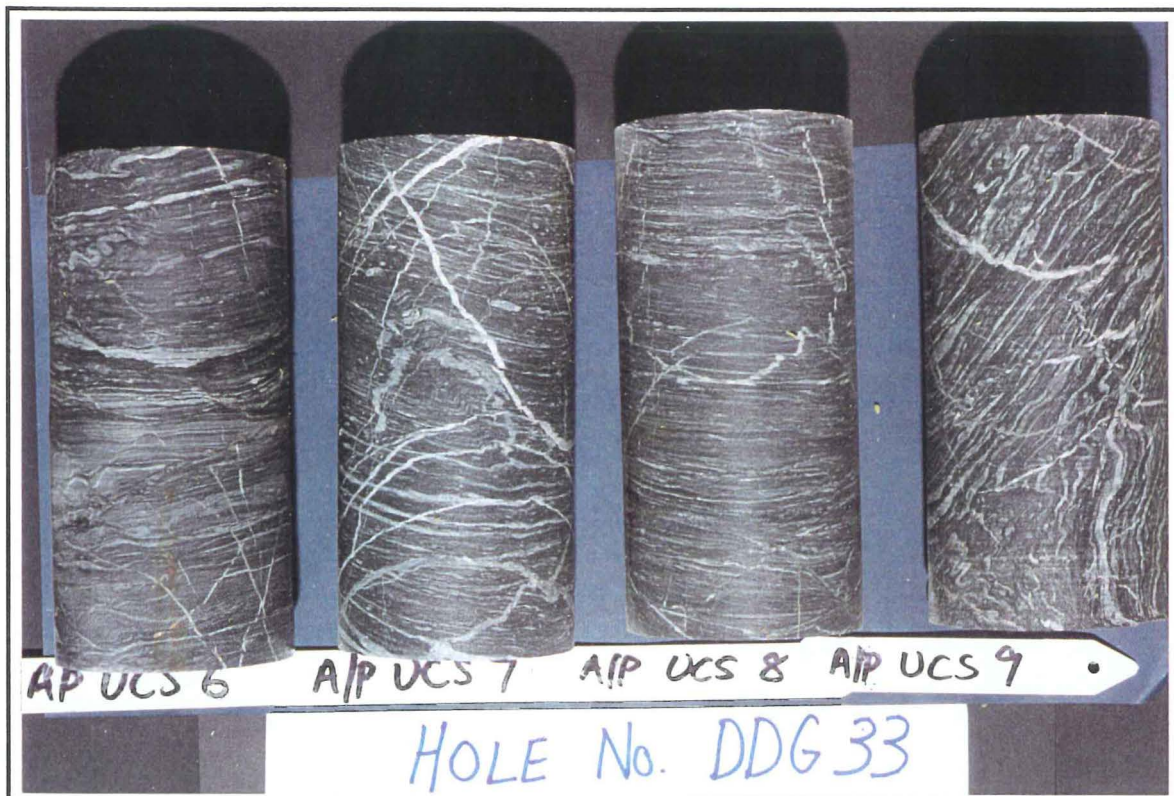
Figure C2-4: Core samples AP UCS 6, AP UCS 7, AP UCS 8, and APUCS 9 prior to UCS testing. Hole No. DDG33 (69919mE, 15374mN). Core size is PQ (83mm diameter).

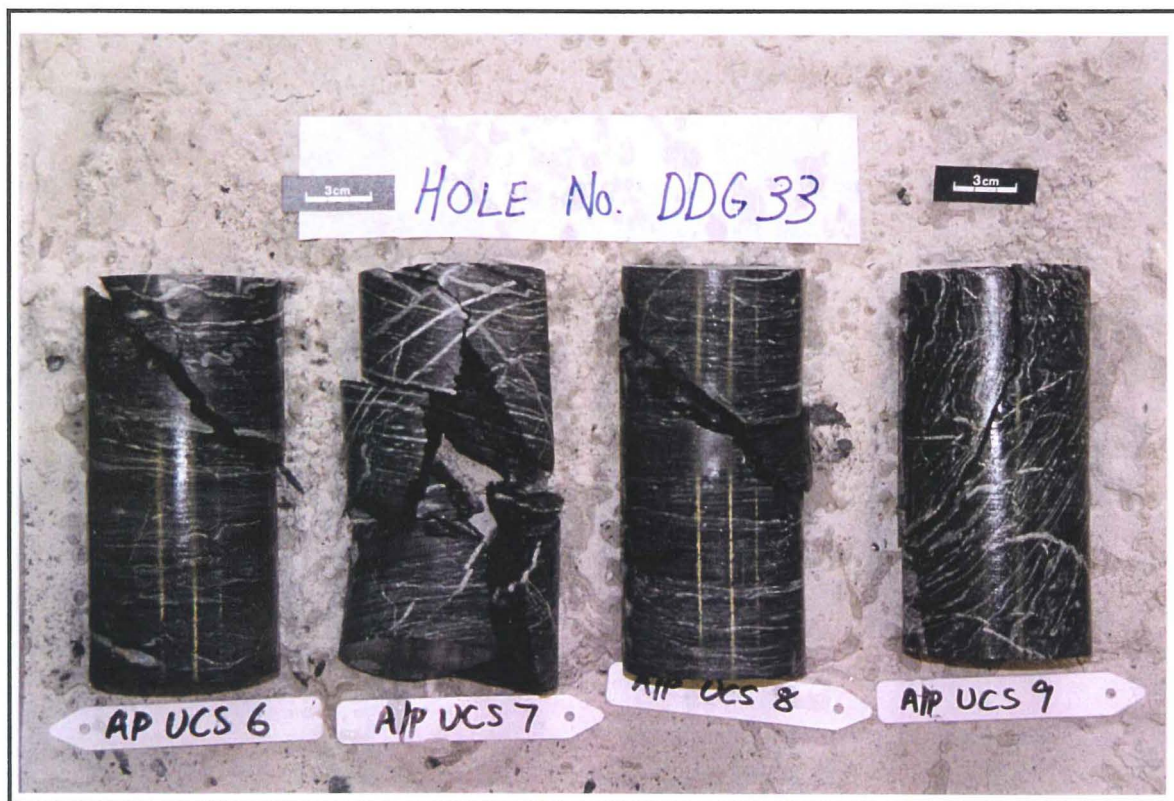
Figure C2-5: Core samples AP UCS 6 (8.7 MPa), AP UCS 7 (34.5 MPa), AP UCS 8 (29.5 MPa), and AP UCS 9 (4.8 MPa) after UCS testing. Hole No. DDG33 (69919mE, 15374mN). Core size is PQ (83mm diameter).

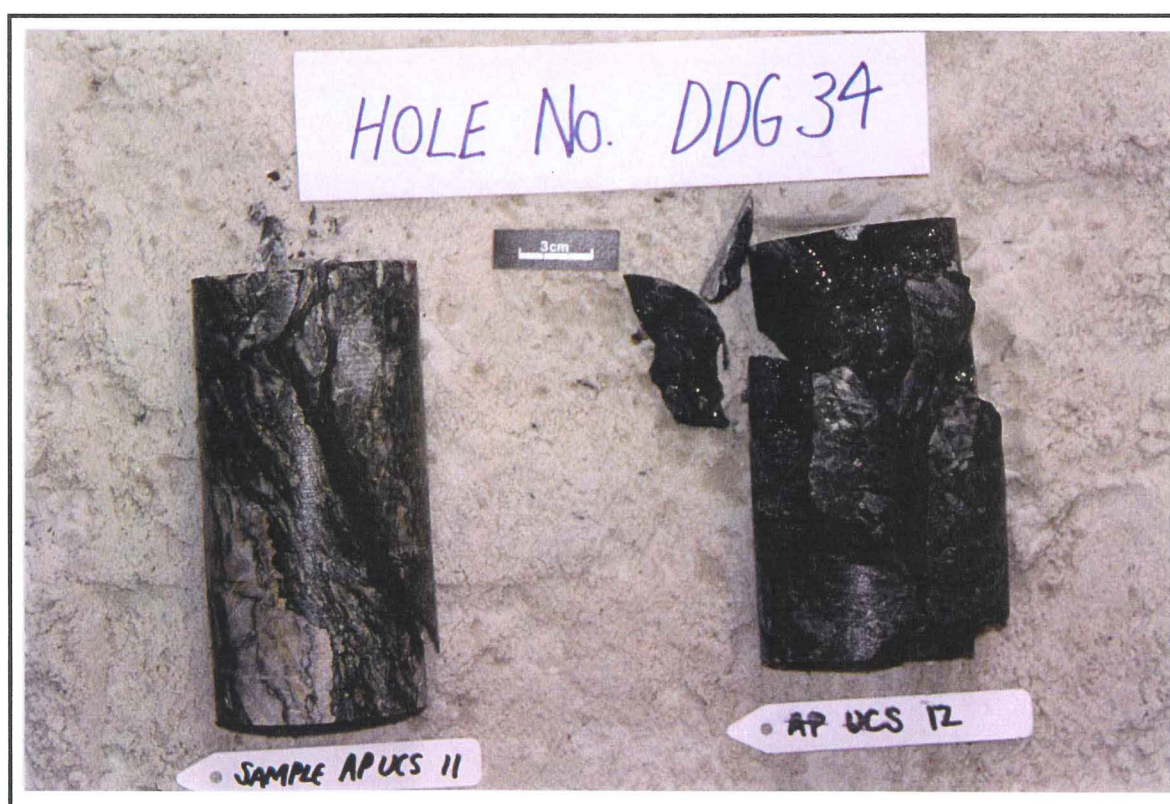
Figure C2-7: Figure C2-6: Core samples AP UCS 11 (15.6 MPa) and AP UCS 12 (29.5 MPa) after UCS testing. Hole No. DDG34 (69973.9mE, 15248.5mN). Core size is PQ (83mm diameter).

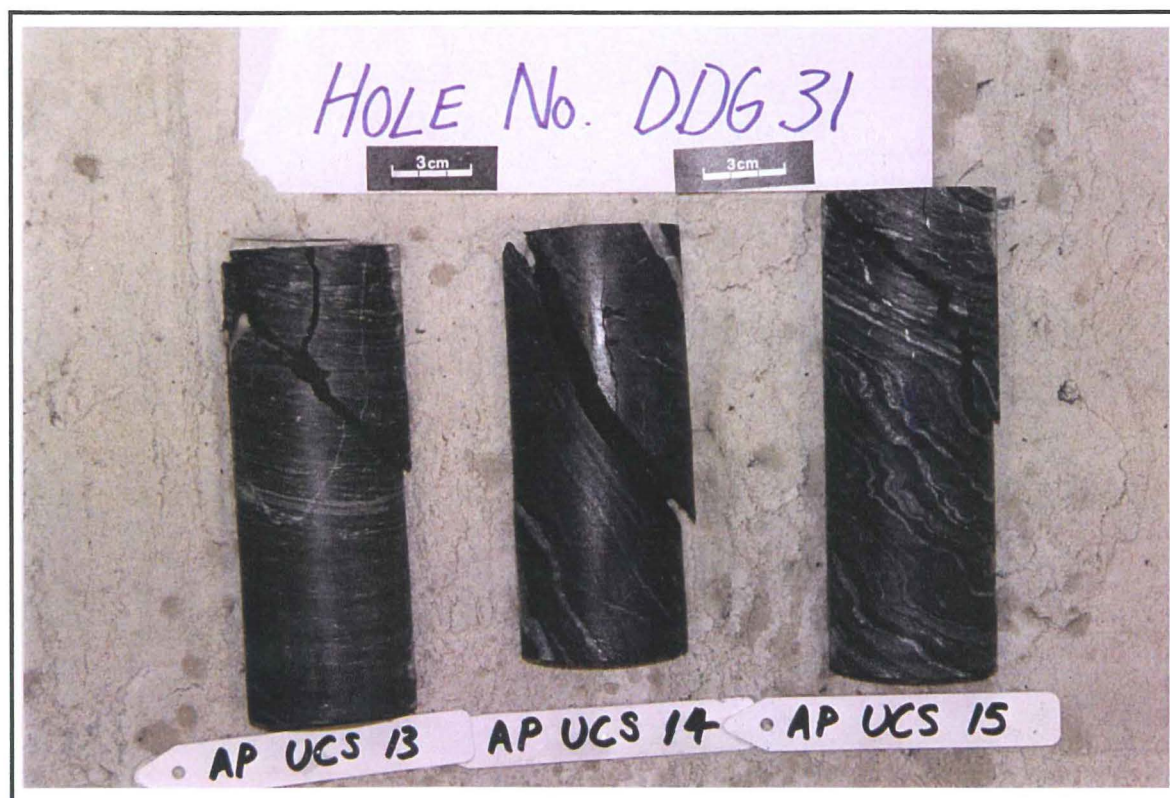
Figure C2-9: Core samples AP UCS 13 (61.2 MPa), AP UCS 14 (18.1 MPa) and AP UCS 15 (10.0 MPa) after UCS testing. Hole No. DDG31 (70137mE, 13581.7mN). Core size is HQ (61mm diameter).

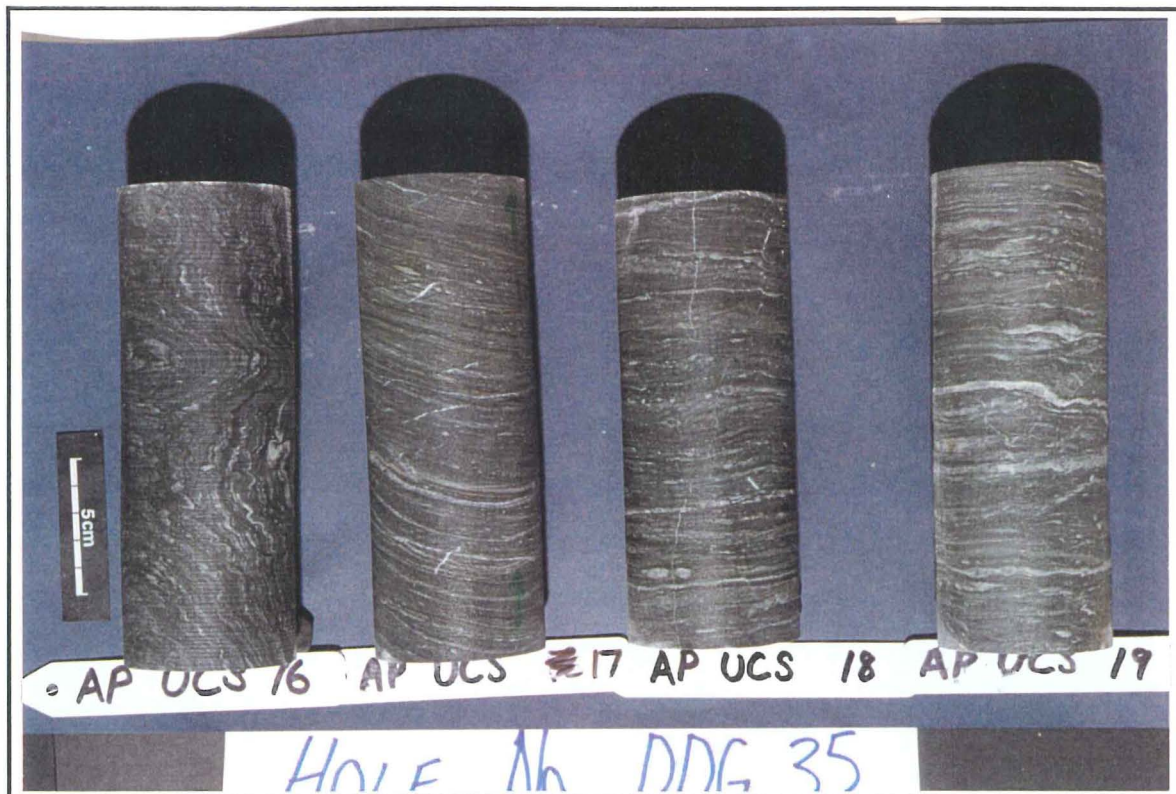
Figure C2-10: Core samples AP UCS 16, AP UCS 17, AP UCS 18 and AP UCS 19 prior to UCS testing. Hole No. DDG35 (70122.6mE, 13581.7mN). Core size is HQ (61mm diameter).

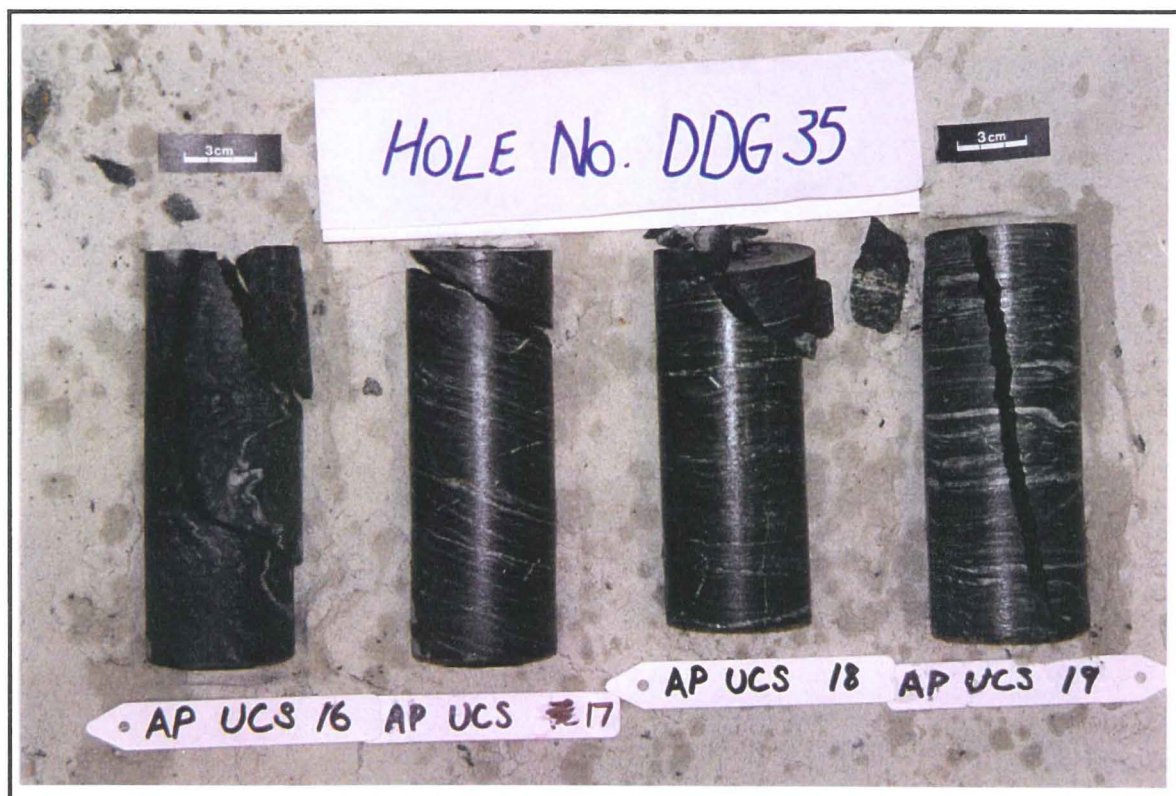
Figure C2-11: Core samples AP UCS 16 (12.7MPa), AP UCS 17 (21.1 MPa), AP UCS 18 (13.6 MPa) and AP UCS 19 (20.5 MPa) after UCS testing. Hole No. DDG35 (70122.6mE, 13581.7mN). Core size is HQ (61mm diameter)
